OCEANS RITZ PARKING DECK REHABILITATION PROJECT

Project Summary #1
Reporting Period: 4.23.2018 thru 5.4.2018
Daytona Beach Building Permit # C1711-057

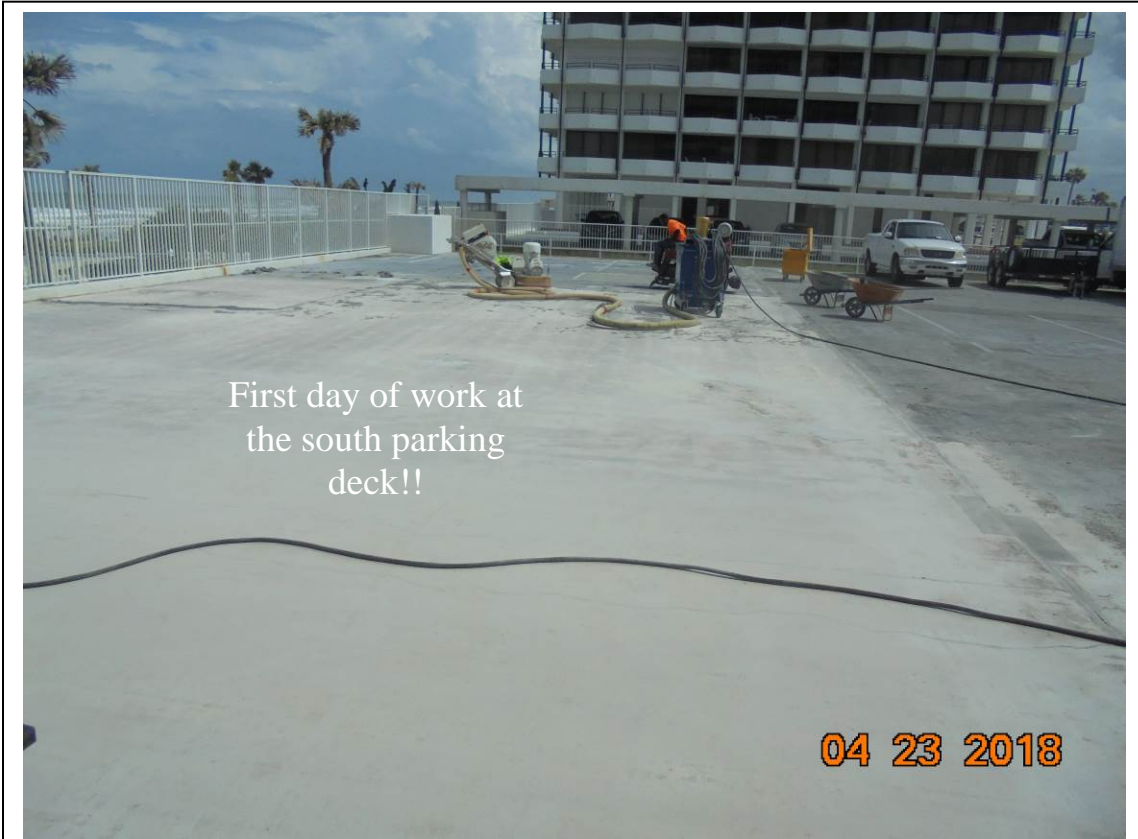
04 23 2018

First day of work at
the south parking
deck!!

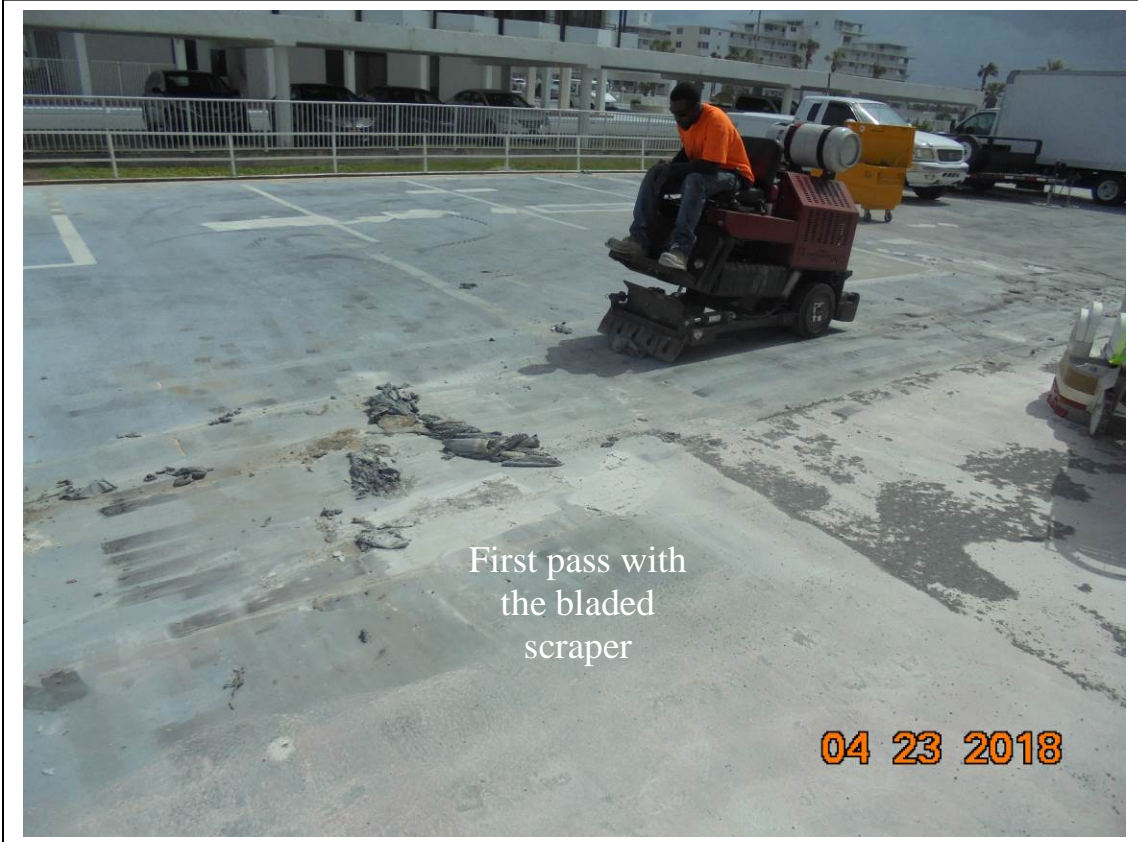
First pass with
the bladed
scraper

The sub-contractor mobilized a variety of specialized equipment to strip the deck coatings that required five to six personnel to operate the assembly-line process. The first pass was with a ride-on scraper to break the majority of the polyurethane free from the substrate followed by a shotblast using small spheres, grinding with dustless equipment and finally another shotblast to create the Keystone specified concrete surface profile (CSP) of a 3 to 4 as evaluated with the chips from an International Concrete Repair Institute (ICRI) Guideline for optimum adhesion of the waterproofing system. The sub-contractor wrapped up their work on April 30th and demobilized until called back for the north deck.

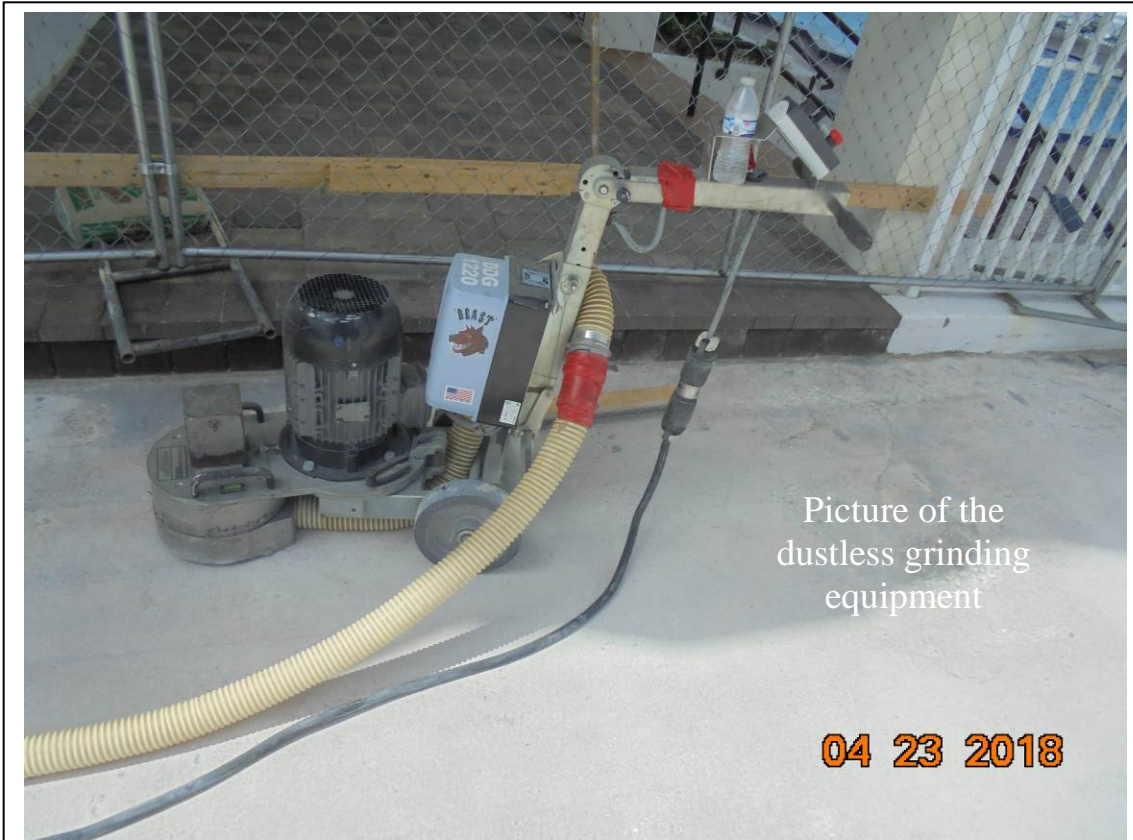
Picture of the dustless grinding equipment

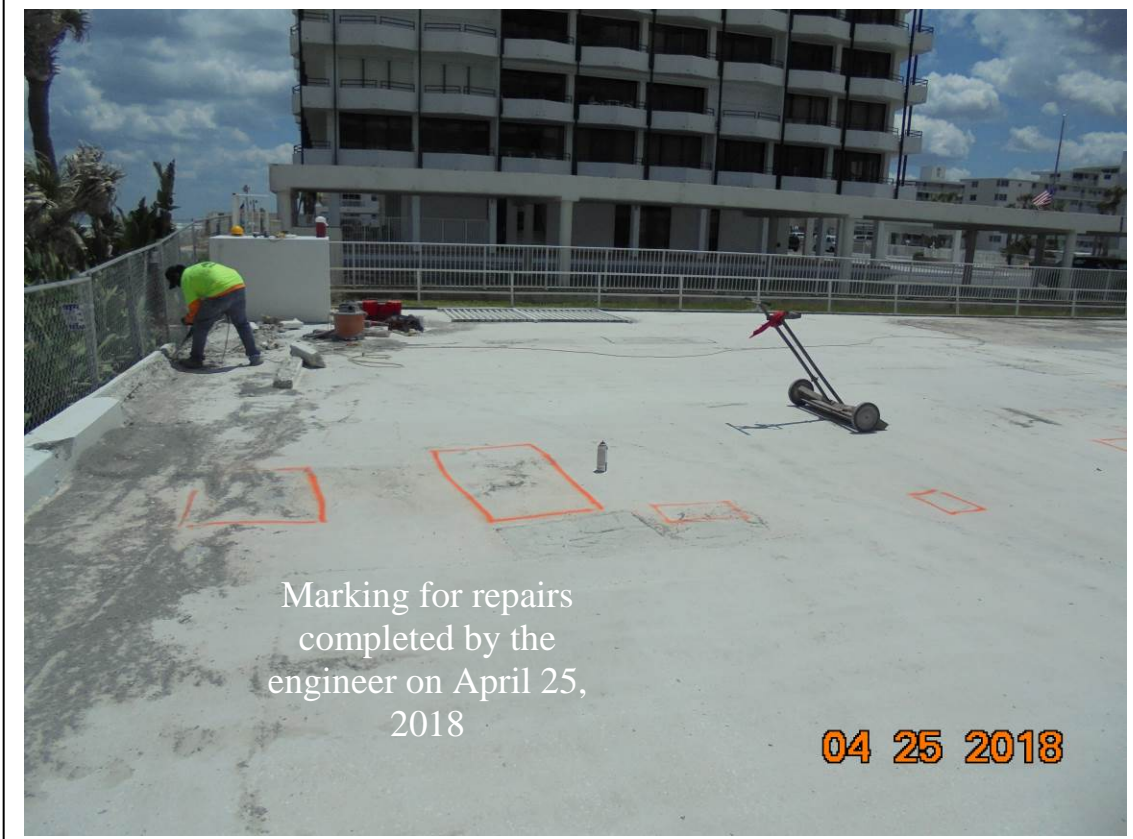
Marking for repairs completed by the engineer on April 25, 2018

The engineer sounded the stripped deck at the eastern bay during week #2 and spray-painted boundaries for excavations where spalling existed with the crew immediately attacking with the chipping hammers. The east beam and parking deck curb of the parking deck was excavated until sound concrete and non-bond inhibiting reinforcement was reached to comply with ICRI standards. Keystone provided instruction for epoxy set doweling of new reinforcement at the east beam rather than cleaning the existing steel and inspected the area on May 3, 2018 as a pre-pour evaluation granting approval to cast.

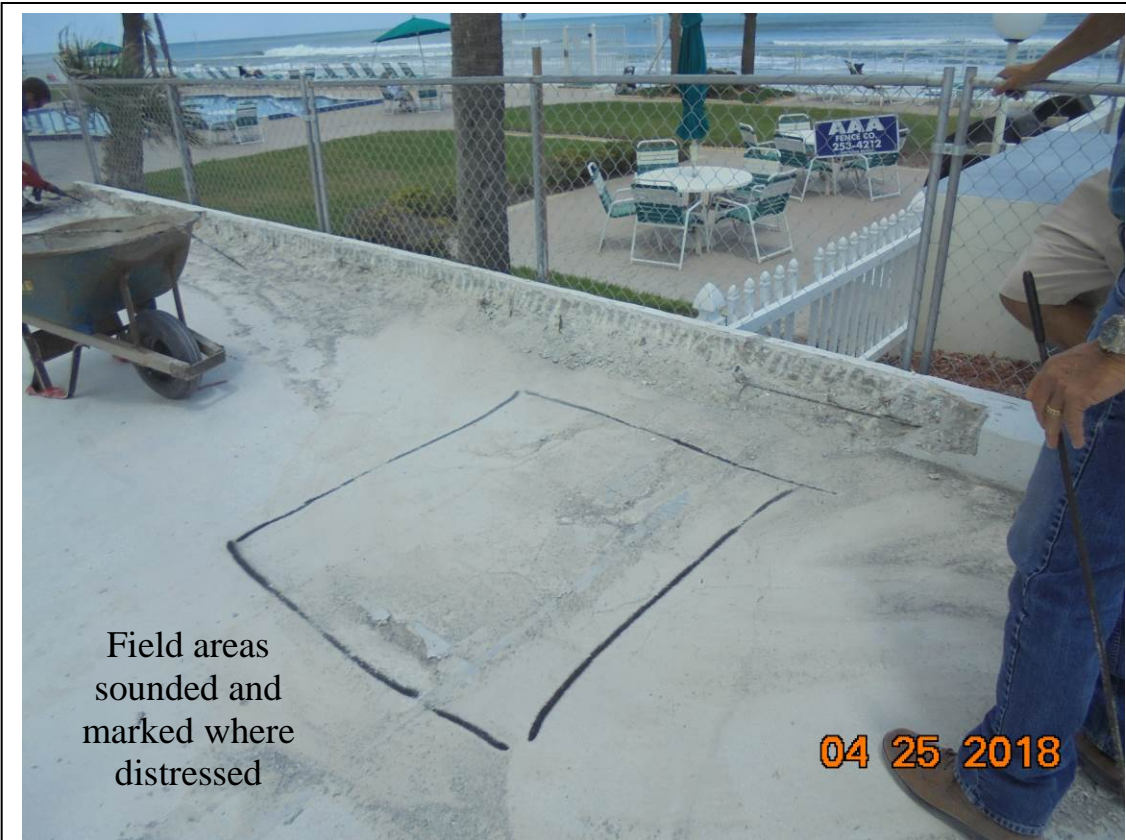
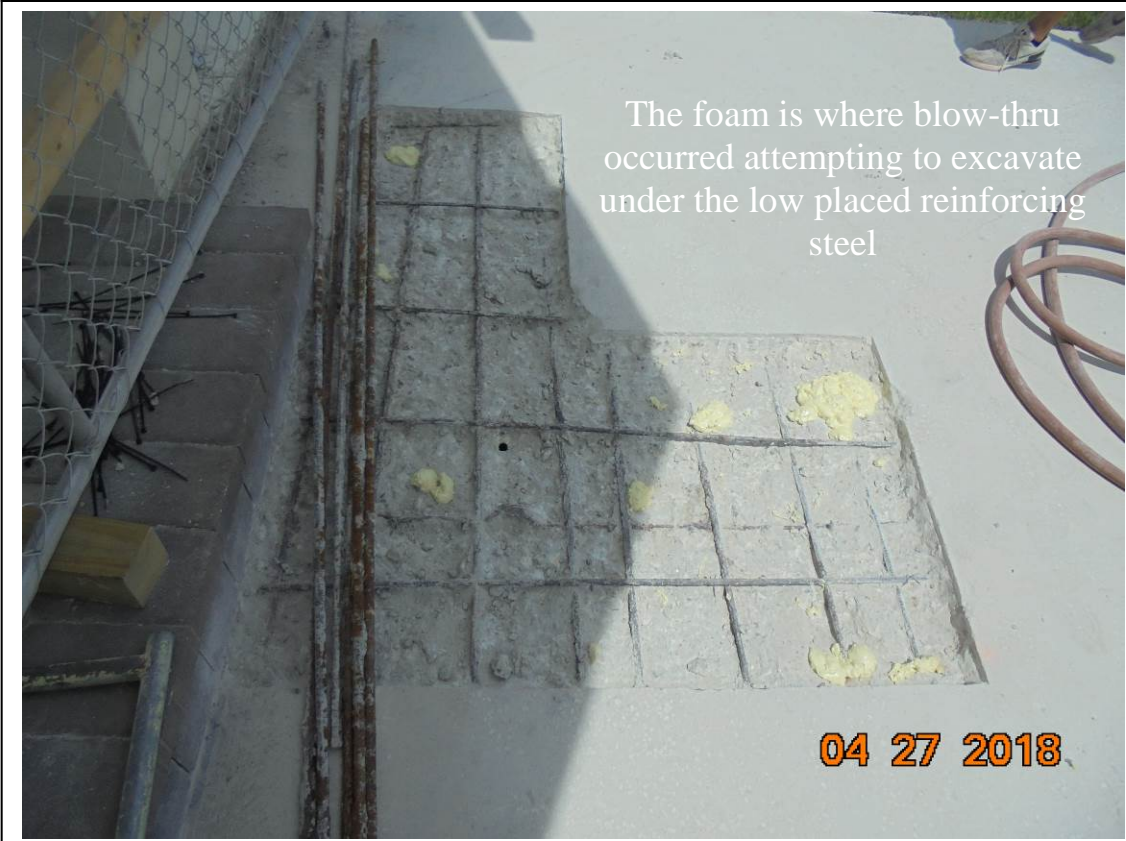
East beam
and curb
excavated as
directed by
engineer

Note the degree of
corrosion in the
excavated area and the
steel is too close to the
bottom of the slab to
avoid full depth repairs

The repairs were mapped on drawings and documented on a Record of Repair submitted to the contractor and association for accountable billing of Unit Rate repairs. During the excavations some locations ended up full depth of the slab that was an average of four-inches deep with the steel placed about one-inch from the bottomside during original construction. Keystone amended the surface repair plan to a full depth excavation at all field areas that will be invoiced at the rate of a surface spall listed in the contract to ensure a durable restoration is accomplished. Plans are to have the initial casting of the field excavations late during week #3 or early week #4 using ready-mix concrete and a concrete pump for placement.
